Deansgate Viaduct - Manchester

"Key hole Surgery for Bridges"

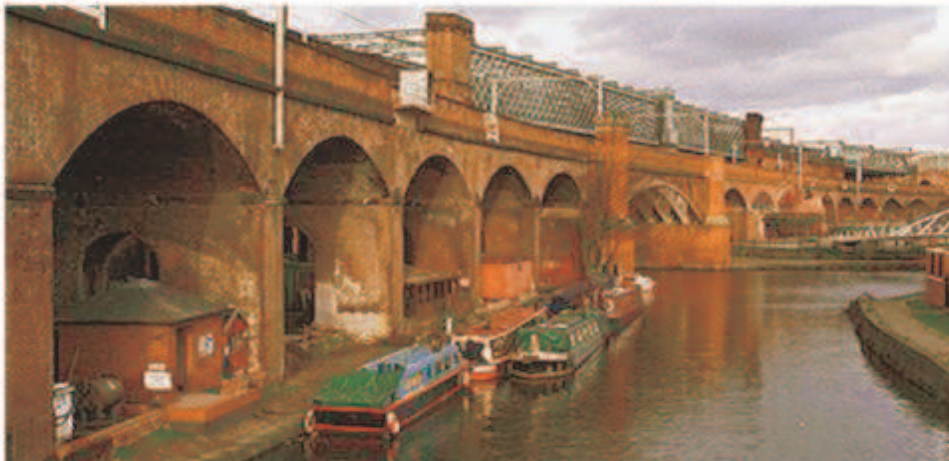
The busy Deansgate rail viaduct is situated in the heart of Manchester spanning numerous buildings, roads and canals. In 1997 the normal daily flow of rail traffic was disrupted by a destructive fire which took hold in a workshop located directly underneath. The subsequent heat generated by the blaze caused extensive damage and a weakening of the seven rings of masonry that form the arch barrels. The surface ring of brickwork completely delaminated and collapsed to the ground below.

A team of consulting engineers assessed the damage and recommended a Cintec reinforcement solution. Any remnants of the outer ring were completely removed and the remaining six rings were hammer tested to locate the extent and

area of internal delamination. Two arches were found to be in need of repair. In total approximately 500, 24 inch long RAC Cintec anchors were installed, perpendicular to the arch and at spacings of 20 inches. The anchors were staggered to avoid the formation of sheer lines and because of their vertical aspect, each anchor was fitted with an air-vent tube to ensure full grout inflation without risk of air pockets being formed at their remote end. All anchors went no further than half way through the sixth ring so as not to puncture the original waterproof membrane that protects the arch barrel from the arch infill.

Finally the original appearance of the arches was restored by grouting an original piece from the drilled cores back into the mouth of each anchor hole. The completed work was rendered invisible to the naked eye and the viaduct was once again in operation servicing Deansgate station and the G-Mex conference centre.
