WORCESTER VIADUCT

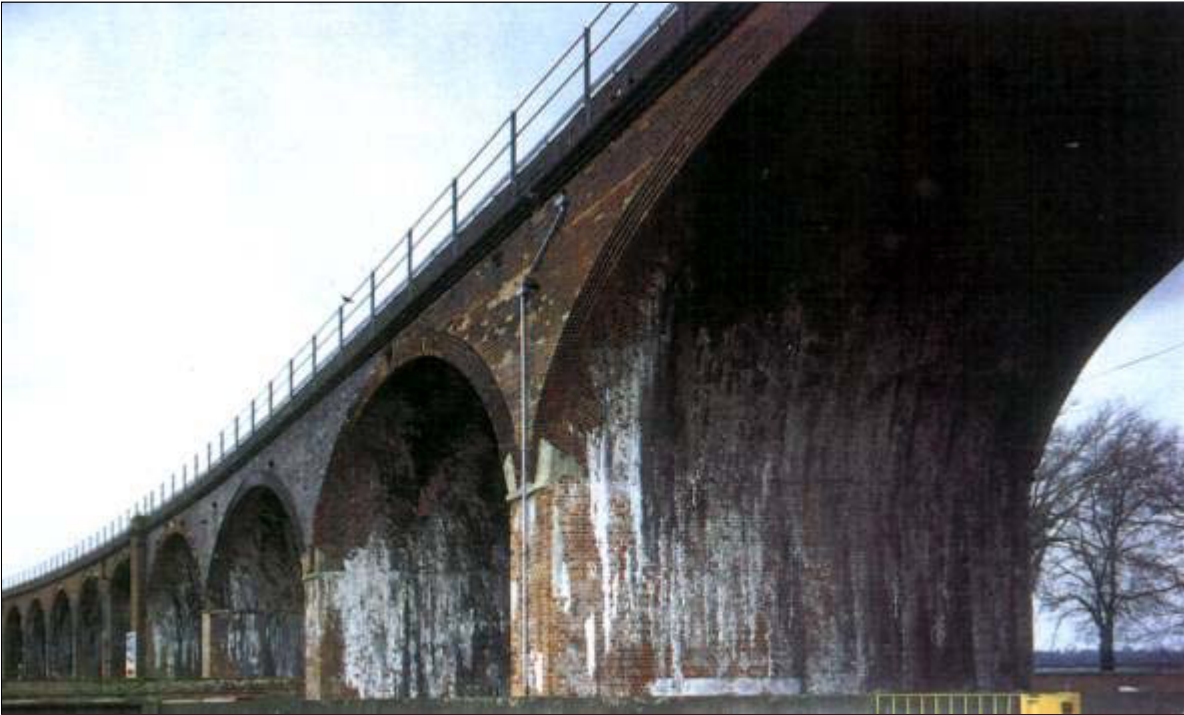
Worcester Viaduct comprises of sixty-five brickwork arches rising from approximately two-storey height near the railway station, to over three-storey height as it approaches the river. Lack of proper draining within the arch had led to the spandrel walls being forced away from the intrados arch with longitudinal cracks close to the longitudinal edges of the bridge. Water penetration had also contributed to cracking at the springing of some spans and delamination of external parts of some columns. These problems had been exacerbated by weathering, particularly freezing and thawing. Previous attempts to restore the structural integrity were evident, but had proved ineffective.

Transverse 30 mm x 30 mm x 3 mm SHS stainless steel WSA anchors were installed to restore the integrity of the spandrel wall/intrados arch connection at approximately 750mm centre-to-centre and alternate lengths of 2.0m and 2.5m. Stitching anchors were then angled across longitudinal cracks to restore structural integrity and the cracks were then filled. Transverse and diagonal stitching anchors, type RWT 15 x 15 x 1.5 SHS stainless steel, were installed to restore the strength of the delaminated columns and the cracks filled. Drainage holes were drilled through the intrados and plastic pipes installed to relieve the existing water pressure. To date five spans have been renovated using the Cintec system and further spans will be renovated as part of an ongoing maintenance programme.
