Churches in Australia and New Zealand

Cintec Australasia has been responsible for the repair and strengthening of a number of significant church buildings in Australia and New Zealand. Starting with the earthquake restoration of Christ Church Cathedral, Newcastle which used some 4000 m of Cintec anchors (see separate **Cintec** publications), **Cintec** has gone on to provide sympathetic and cost-effective masonry strengthening solutions when alternatives involved demolition and rebuilding.

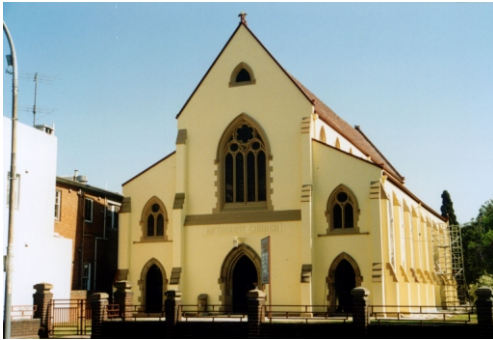
◀ Methodist Church, Maitland, NSW (1858). This building suffered damage in the 1989 Newcastle earthquake. 6 m Cintec anchors were used in the wall buttresses to provide the additional strength required to resist future seismic damage.

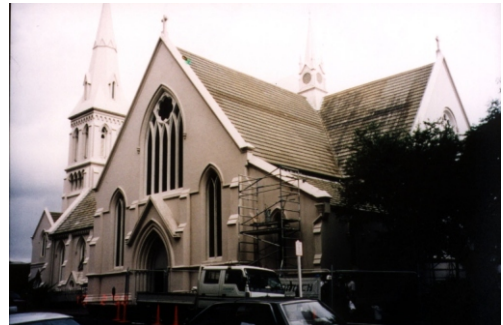
St Patrick's Cathedral, Auckland New Zealand (1885/1907). Cintec anchors up to 3 m long have been used to repair cracking from foundation movement. ▶

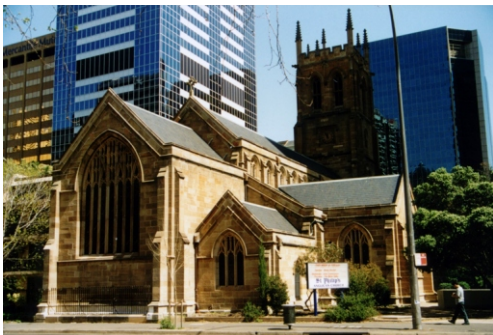
◀ St Philip's Church, Sydney, NSW (1856). Roof spread had led to wall cracking at eave level. Cintec anchors provided the economical repair solution with a guaranteed long life with no visible affect on the building.

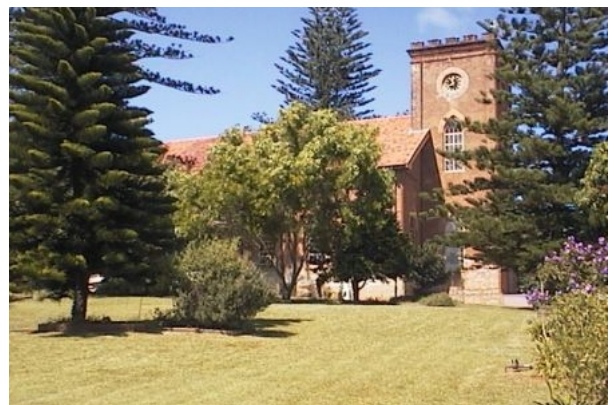
◀ St Paul's Church, Spring Hill, Brisbane, Queensland (1889). In order to protect the deteriorating stone spire of this church with a copper-clad cover, the tower had to be strengthened. 6 m long Cintec anchors in each corner of the tower provided the necessary extra strength. The tops of the anchors were threaded to fasten the frame of the cover.
