CASE HISTORY

FULLER'S BREWERY, LONDON U.K.

TRIAL BY FIRE

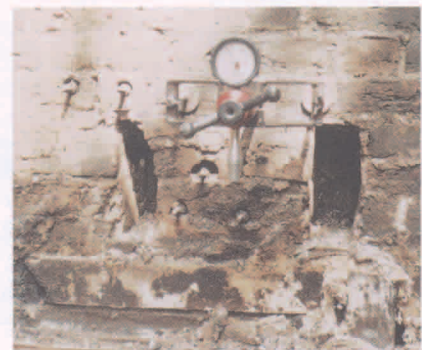
Remedial anchors installed prior to the fire. The anchors are still functioning. The grout cover protected the main steel body of the anchor.

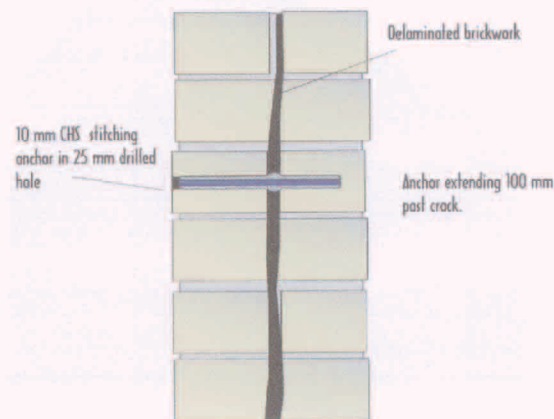
fig. 1

After the fire the proposal was to consolidate all delaminated brickwork (fig. 1) using Cintec RAC anchors, allowing repairs of the internal delaminated skin to be undertaken without risk of further failure to the masonry. At the same time the major cracks were stabilised using Cintec SHS anchors (fig. 2).

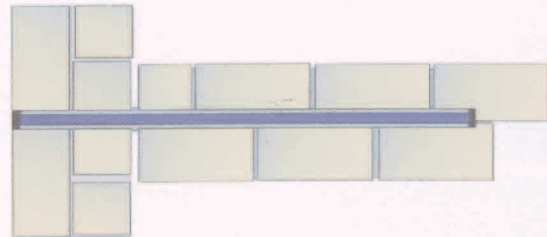
fig. 2

15 x 15 mm SHS stitching anchor 1500 long installed in a 32 mm drilled hole.
