CINTEC ANCHORS FOR HISTORIC
BODIAM BRIDGE

Tim Bilson

Scoll Wilson Kirkpatrick

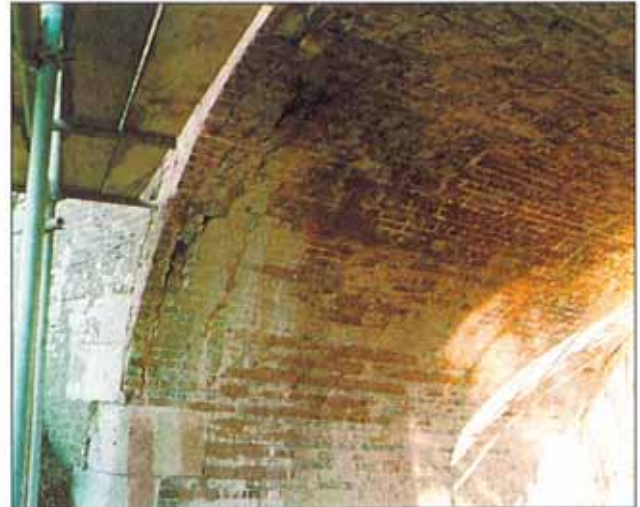
Typical damage to the soffit of the bridge

The most recent remedial work involved the repair of cracking in the brickwork. The concentration of the damage in the two side spans of the three span bridge suggested that the initial cause was

possibly impact loading towards the ends of the bridge before the 'hump' was levelled out in 1982. This impact loading will have had the effect of forcing out the spandrel walls. Frost damage during the cold winters of 1986 and 1987 and washing out of mortar have further developed the initial effects. This has led to cracking of brickwork adjacent to the arch voussoirs, some movement in the spandrel walls, and delamination of the wing walls at the south end.

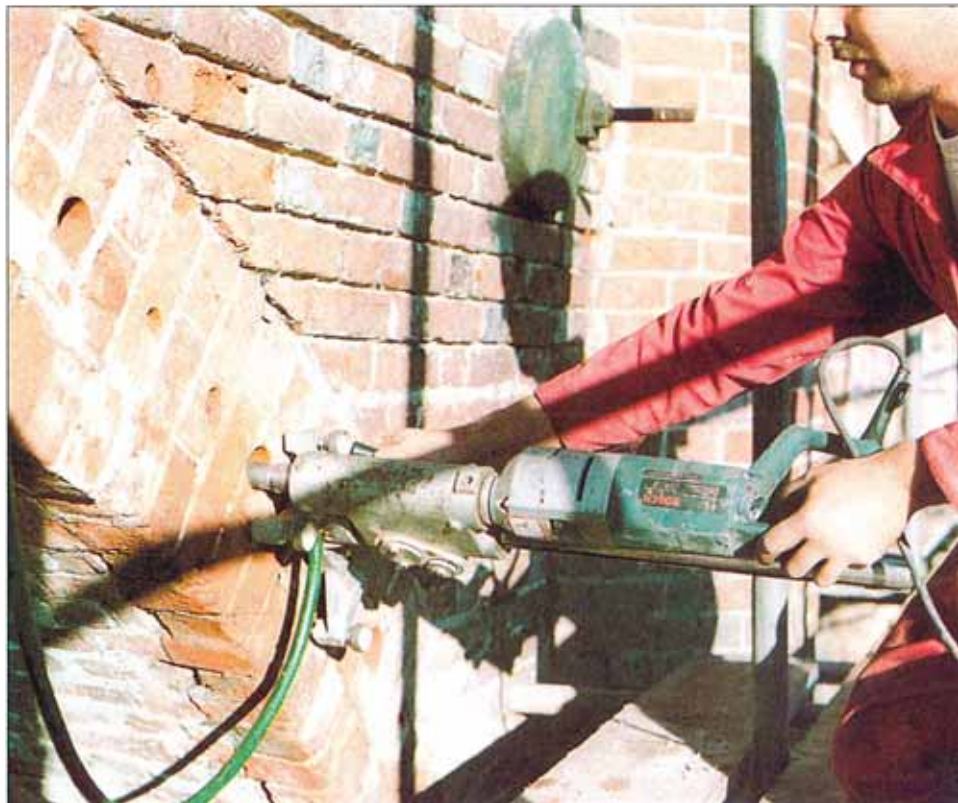
Core drilling holes for the anchors

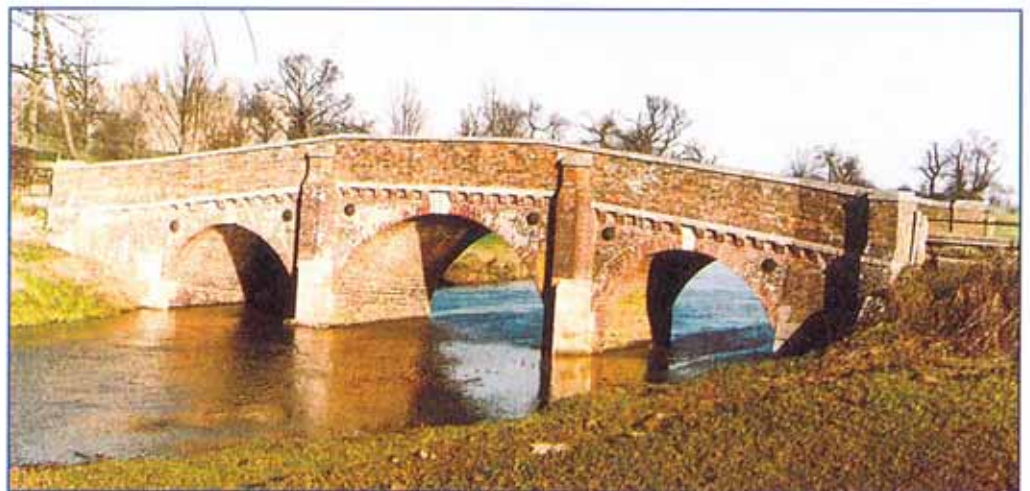
Bodiam bridge after completion with the castle behind the trees in the background.

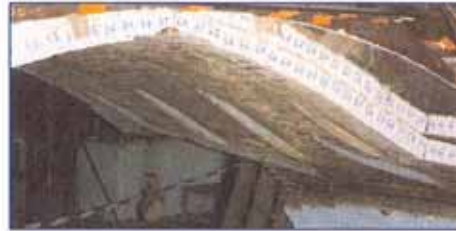
The conclusion of the TRL test, after a load failure point was raised to 41 tonnes. The picture clearly shows the exposed anchors retaining load-bearing capacity.
