# CASE HISTORY

## *CHRIST CATHEDRAL NEWCASTLE NEW SOUTH WALES, AUSTRALIA*

## CHRIST CHURCH CATHEDRA, NEWCASTLE, NEW SOUTH WALES, AUSTRALIA — THE REPAIR

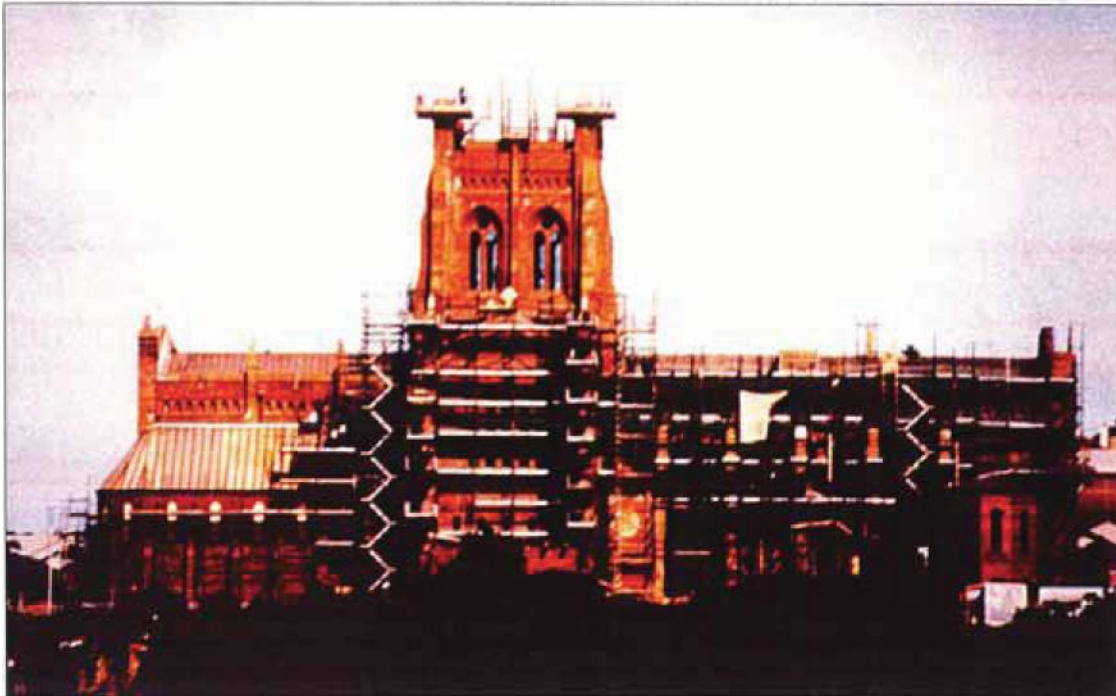
The effect of the earthquake was largely as might be expected: high set stone crosses and other decorations fell to the ground, flying buttresses were dislodged, shear cracking occurred in the north and south walls and out-of-plane movements occurred in the east wall, dislodging windows.

Work on a building such as Christ Church Cathedral is governed by State heritage legislation which invokes the International Council on Monuments and Sites (ICOMOS) principles derived from the world body's Venice Charter. To repair and strengthen the Cathedral, reinforcement of the walls was necessary, with least visual intrusion or damage to the existing fabric. Material had to be found which were compatible with the masonry of the building and which ensured the long life for which cathedrals are noted.

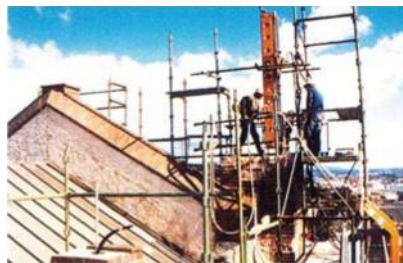
*Down-the-hole video was used to verify the integrity of all drill holes and each hole was surveyed for its full length using techniques specially developed on site by the surveyors.*

Water could not be used for drilling because of the damage it could do to the building, so all drilling was carried out with non-coring, polycrystalline diamond bits using air for cooling and cuttings removal.

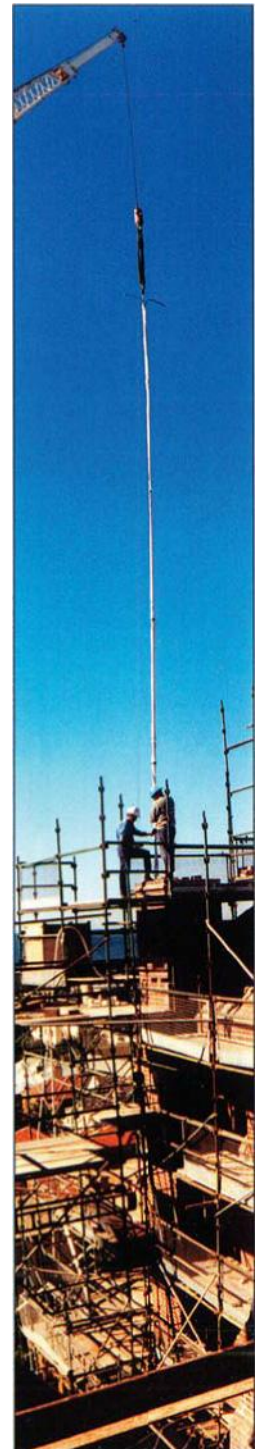
*20 m vertical anchor being placed by crane in the project which saw anchors up to 32 m horizontally, Cintec's longest to date.*

Cintec anchors used on the project ranged from 215 mm long RAC cavity ties to 32 meter long anchors in the nave walls which were manufactured from 32 mm diameter "Hi-proof" grade 316 deformed stainless steel bar. All the long anchors had to be manufactured on site, with long vertical anchors being installed by crane.
