Florida Sea Wall - Subsidence and Dislocation

Marco Island Sea Wall - Florida USA (An early example of Cintec ground anchoring)

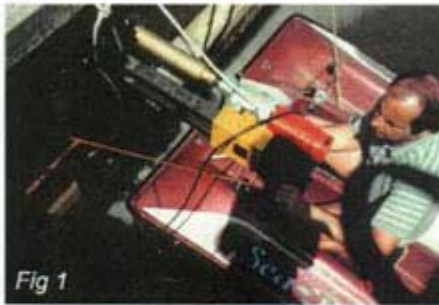
As can be seen in the images (right) the individual boreholes were produced by diamond core drilling, in this case with a core diameter of 65mm (2 1/2") and to the length of the anchor; 3.2 metres (15ft) - Fig 1. The anchors were then installed with a plastic half pipe to facilitate their insertion - Fig 2. Finally the anchors were injected with 'Presstec' cementitious grout expanding them from their far end to the front. Although not essential, a flange-plate was also screwed to the exposed anchor end for additional securement - Fig 3.
