Eglise Aizenay

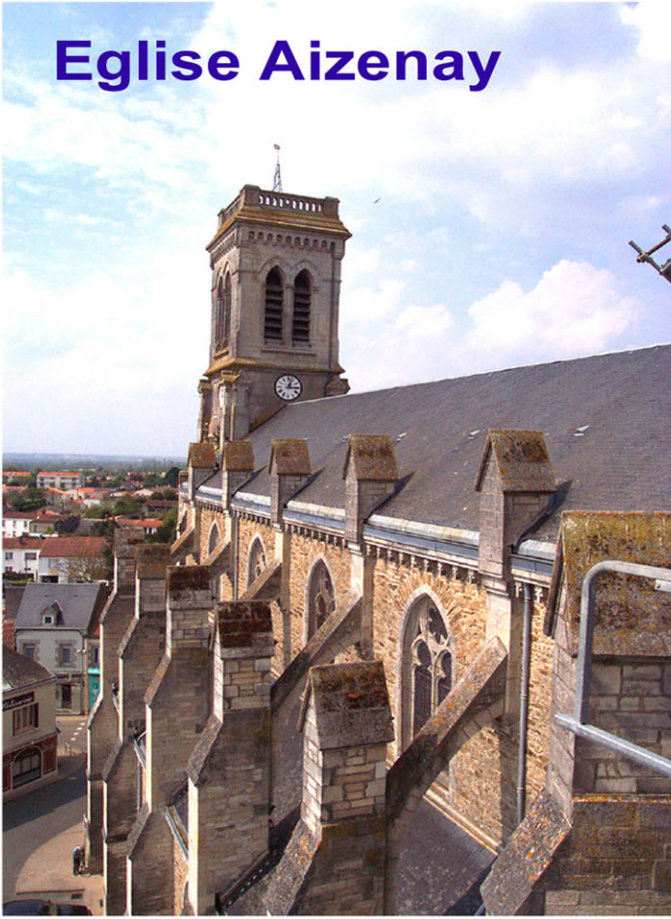
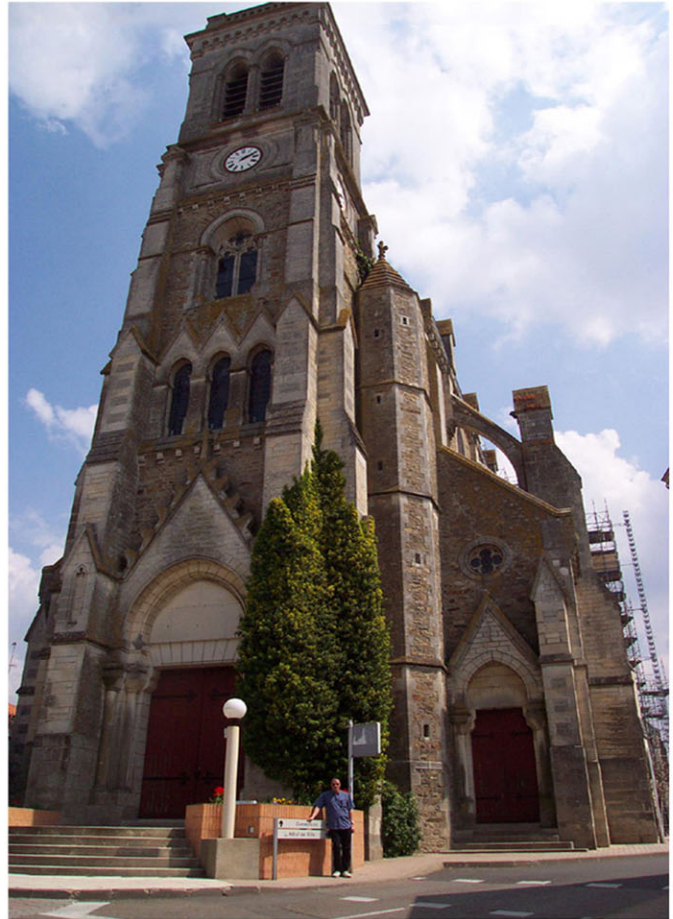
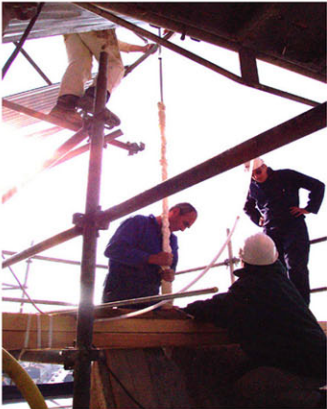
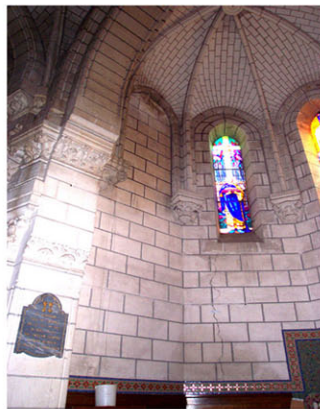
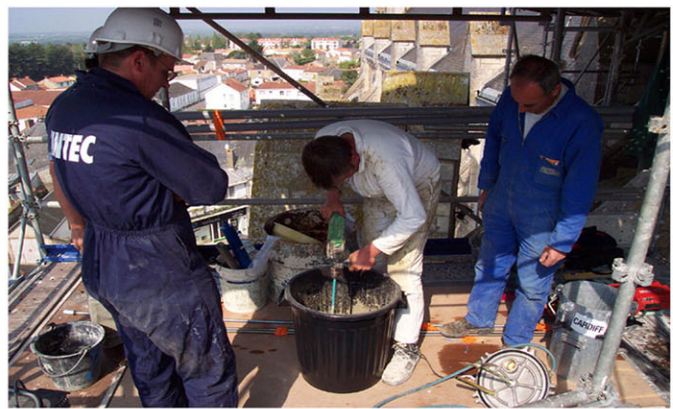
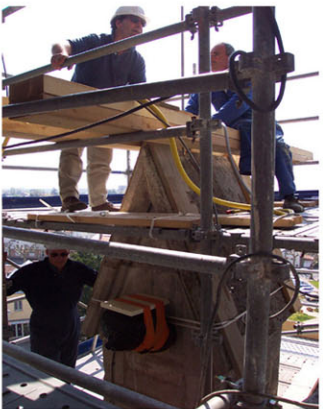
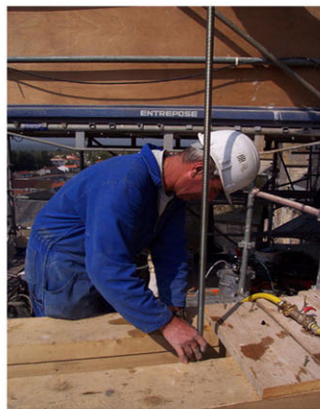
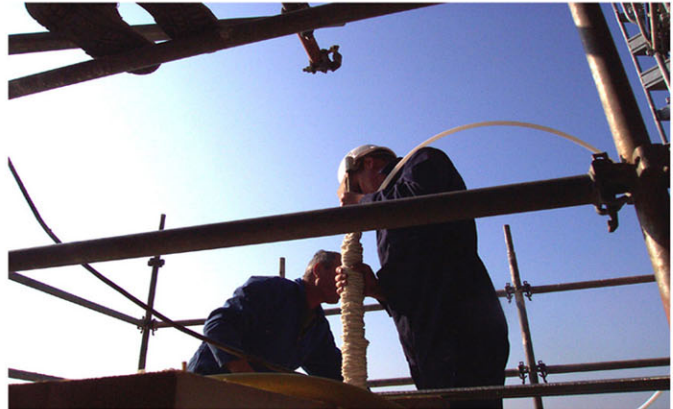
In order to repair damage caused by centuries of seismic activity, This french project involved the installation of 11 metre vertical anchors through the flying buttresses together with 260 RAC consolidating anchors comprised of 40No. 1500mm 10mm CHS RACs plus 110No. 1300mm and 110No. 700mm of the same type.
