CINTEC ANCHORS FOR HISTORIC BODIAM BRIDGE

Cintec anchors for historic Bodiam Bridge

Tim Bilson

Scoll Wilson Kirkpatrick

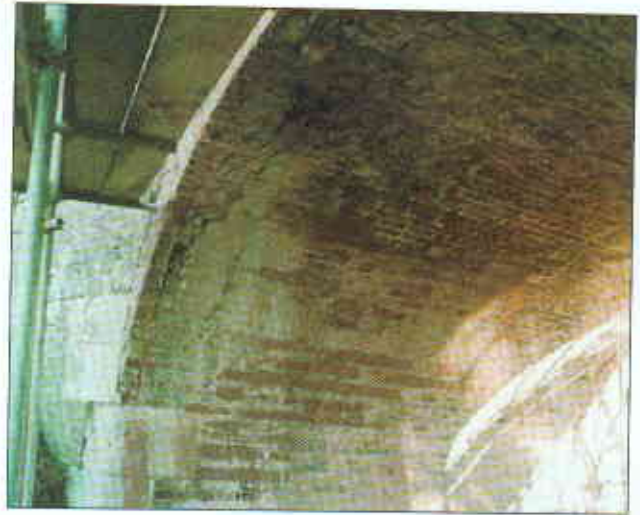
Typical damage to the soffit of the bridge

The most recent remedial work involved the repair of cracking in the brickwork. The concentration of the damage in the two side spans of the three span bridge suggested that the initial cause was

possibly impact loading towards the ends of the bridge before the 'hump' was levelled out in 1982. This impact loading will have had the effect of forcing out the spandrel walls. Frost damage during the cold winters of 1986 and 1987 and washing out of mortar have further developed the initial effects. This has led to cracking of brickwork adjacent to the arch voussoirs, some movement in the spandrel walls, and delamination of the wing walls at the south end.

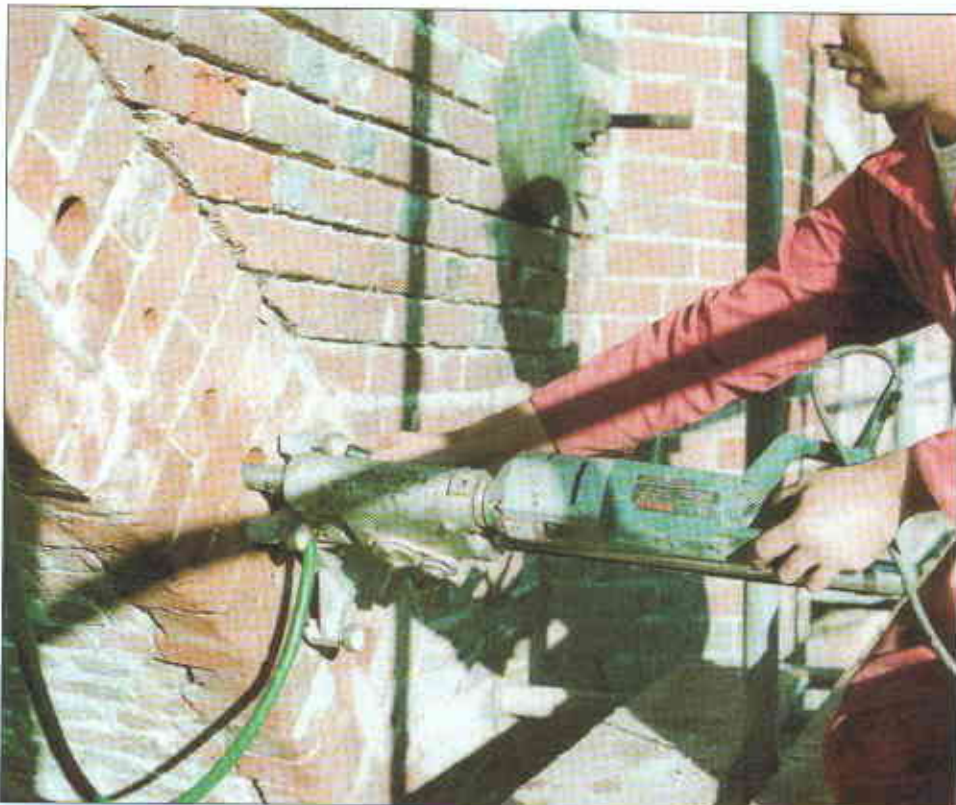
Core drilling holes for the anchors

nearer the centre-line of the bridge causing new cracking at this point. Strengthening of the local edge damage to the brickwork of the arches is achieved with the installation of 450mm long RAC anchors formed with 8 x 1.5mm circular hollow sections. The interspacing of the two anchors allowed the 15mm diameter holes for the small anchors to be used for the fixing of the stand used with the diamond drilling of the 52mm holes for the main anchors, this keeping the making good to a minimum. Following grouting of the anchors the holes were made good with coloured mortar to match the brickwork.

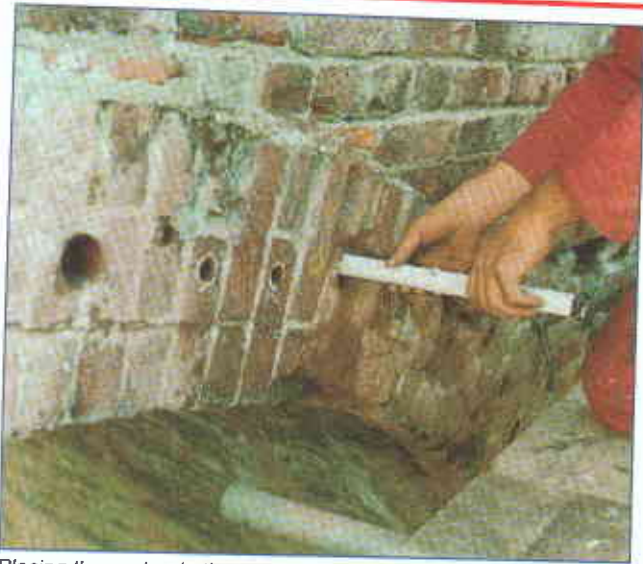
Placing the anchor in the prepared hole

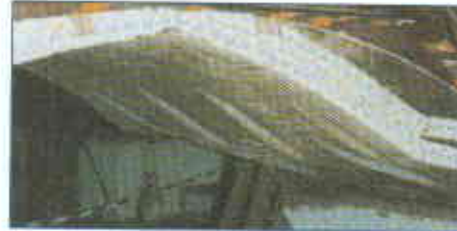
The conclusion of the TRL test, after a load failure point was raised to 41 tonnes. The picture clearly shows the exposed anchors retaining load-bearing capacity.
