CYMER ABBEY - DOLLGELLAU, WALES

NAVE ARCADE STABILISATION WORKS

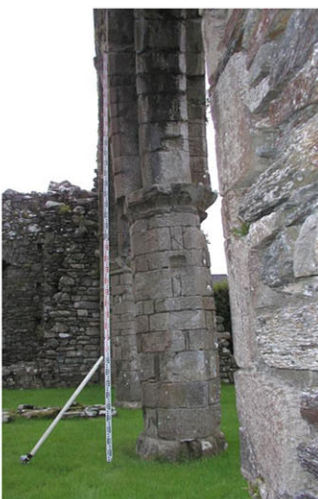
Image revealing the extent of wall and column rotation prior to stabilisation

Under the direction of CADW, structural engineers Mann Williams undertook inspection and monitoring of the abbey. This revealed progressive movement of the north arcade masonry which had become unstable to the point where propping was necessary to prevent collapse. For the long term it was decided to use Cintec structural reinforcements because in the words in Mann Williams *"The technique has been recently used successfully on a scheduled ancient monument, and has the advantage of retaining the largest proportion of the original structure in-situ. On completion of the works there is minimal evidence of the work having been implemented"*.
